Cold Asphalt Concrete Overlay

COLD ASPHALT CONCRETE OVERLAY

INTERIM REPORT

CA-HY-MR-3542-1-72-48

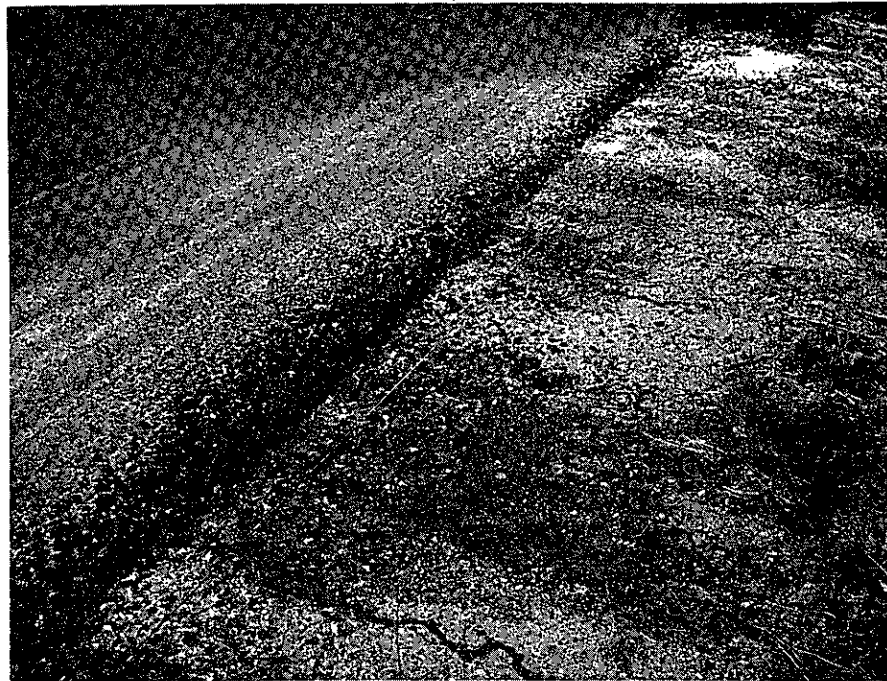
The open graded mixture appeared quite black immediately upon placement; however, some runoff of emulsion was noted on the shoulders as paving progressed (Figure 6). It is felt that the runoff may have actually been caused by the tack coat. The mixture gave the appearance of a good, well coated, conventional, open graded mixture (see Exhibit 3). A sand choker was applied to stop pickup from the rolling operations. The roller was equipped with water to wet the wheels; however, there was still some pickup evident until a detergent was added to the water. Pickup was then minimized; nevertheless, the sand choker was still used on all open graded placed.

Figure 6 - Shoulder Runoff

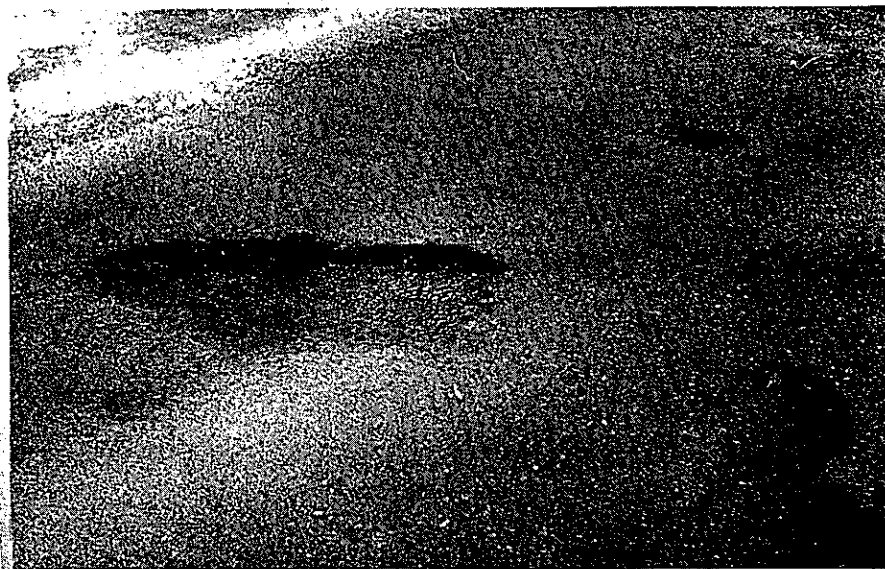
Dense graded mixture was placed using the following construction sequence: (a) placement of the mixture, (b) rolling immediately with a steel tandem roller - 2 coverages. The dense graded mixture did not have a sand choker applied. This mixture after placing appeared to take longer to cure and several wet spots could be detected (Figure 8). After 4 to 6 hours the entire surface was covered by a film of free water.

Figure 8 - Wet Spots Appearing
in Dense Graded Surfacing

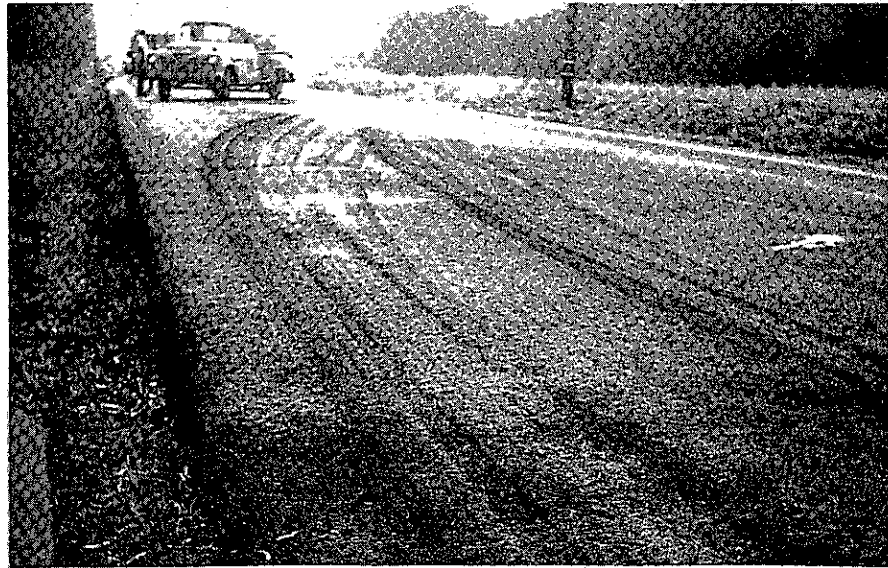
During paving traffic was routed adjacent to the operation by a pilot car. Traffic was allowed on the first open graded section 45 minutes after placing. No visible rutting or distortion was apparent. Traffic was allowed on the dense graded mixture about 1 hour after placing. Slight damage was noted in spots on the dense graded surface where traffic had to turn across lanes to avoid construction (Figure 9). Some heavy trucks, which had to stop due to traffic control, left crescent shaped slippage cracks in the dense graded mat when they started up again.

Figure 9 - Raveling in Dense Graded Due to Turning
4 Hours After Construction

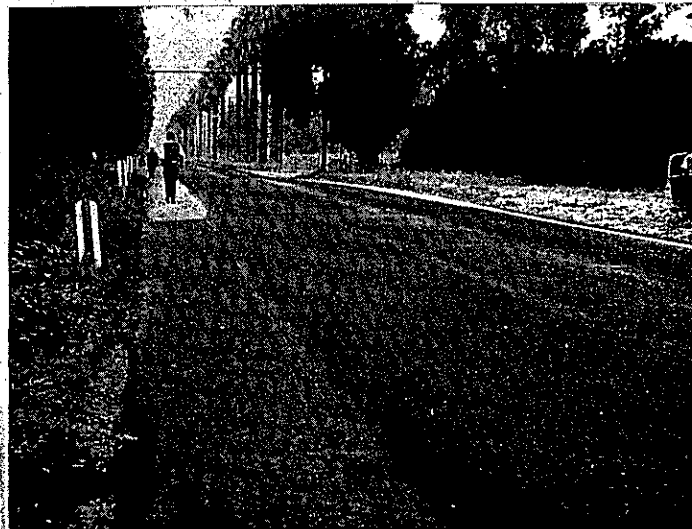
The dense graded mixture also showed a slight amount of raveling after 24 hours (Exhibit 4) and there was visual evidence the mixture had not cured completely. A 2-foot section near each edge of pavement appeared brownish compared to the rest of the pavement, which indicated the asphalt still was emulsified (Figure 10).

Figure 10 - Indication of Insufficient Cure
in Dense Graded Mix

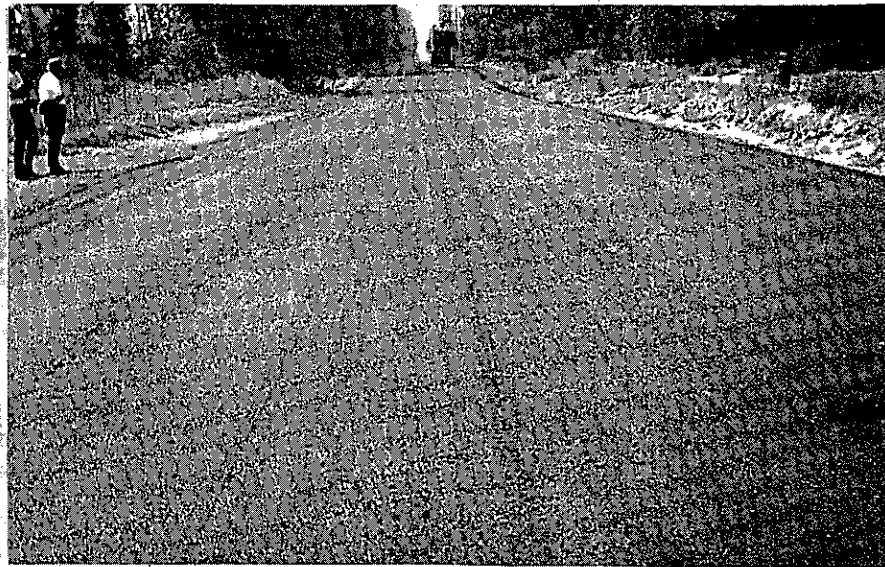
The wheel track areas appeared black and cured; however, this was only a surface condition. The fact that this area was not sufficiently cured in depth was confirmed a few hours later when a fog seal was applied consisting of CSS-1h emulsion diluted three parts emulsion to one part water and applied to obtain a theoretical 0.10 gal. per sq. yd. residue. A short section was not fog sealed for comparative purposes. Traffic was allowed over both areas immediately and, as the emulsion in the sealed section began to break, it stuck to both tires and surfacing. The results were serious tearing and raveling of the surface (Figure 11). Rocks ripped from the surface were thrown by the tires of fast moving traffic, creating a hazard. Sand was immediately brought out and placed on the surface to blot the emulsion. This was successful and additional raveling and tearing of the surface was arrested.

Figure 11 - Dense Graded Surface
1 Hour After Fog Seal

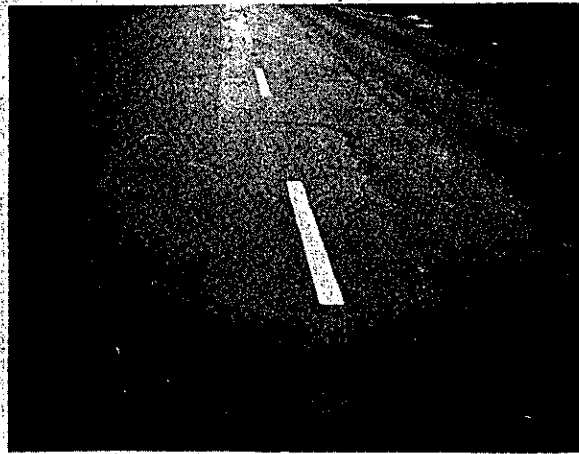
The first pavement condition survey was made after 90-days and the open graded mixture had not deteriorated greatly from initial observations. It was evident, however, that a few aggregate particles were still being displaced and a few areas in the wheel tracks were definitely beginning to indicate raveling. Hairline cracks were easily visible with the pavement wet and were an indication of reflective cracking (Figure 12).

Figure 12 - Reflective Cracks in Wet Open Graded Pavement After 90 Day's Service Life

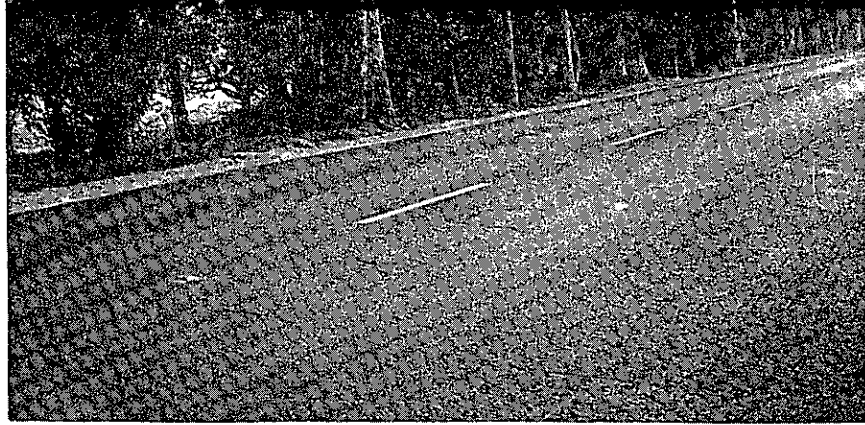
The next field review occurred approximately six months after construction and revealed that the open graded mix had deteriorated. Previously observed hairline reflective cracking had increased and some cracks were spalling (Figures 13 and 14). There was

Figure 13 - Reflective Cracking In Open Graded Surface

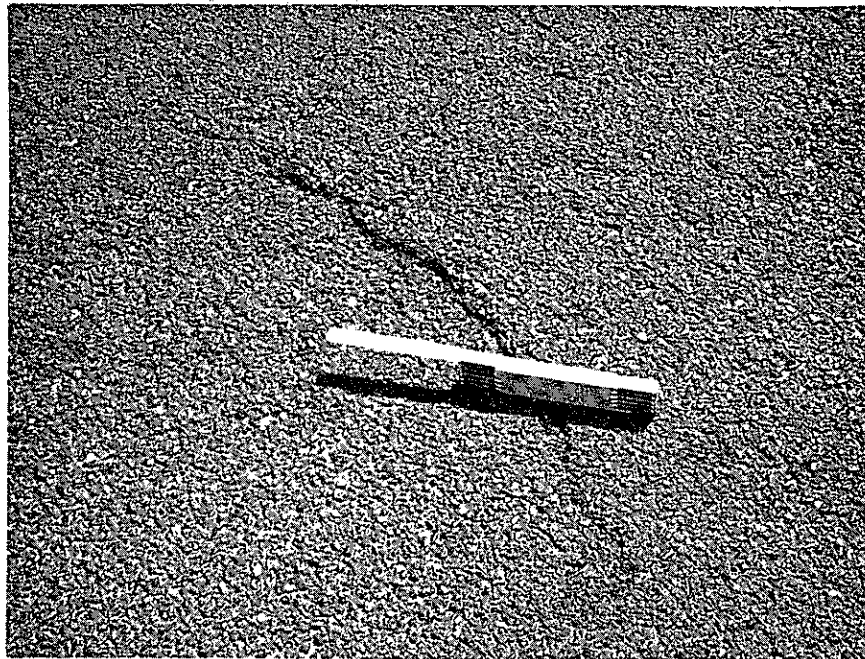
Figure 14 - Raveled Reflective Crack in Open Graded Surface

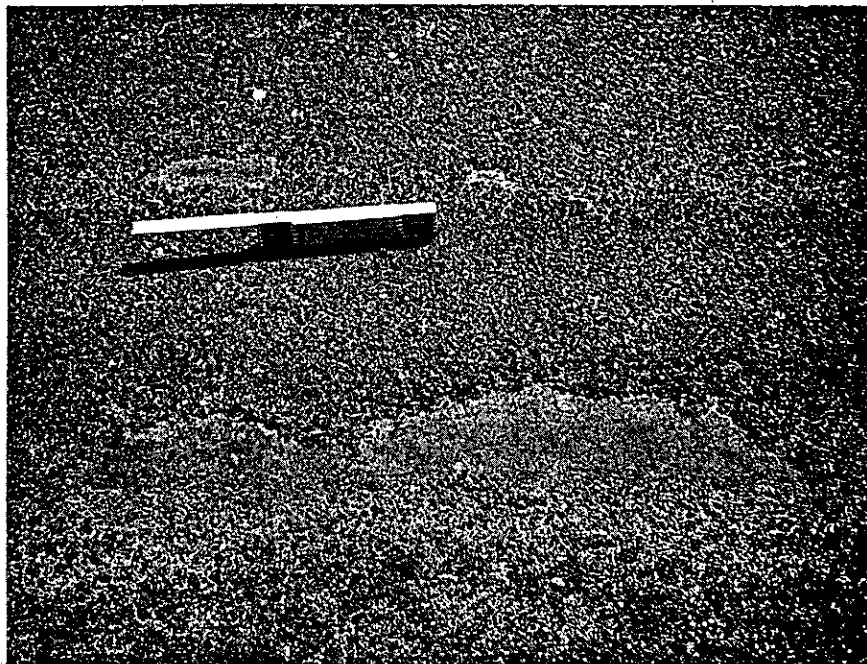
some raveling through to the overlayed surface and raveling along the edge of pavement (Figure 15).

Figure 15 - Raveling in Open Graded Surface
After Six Months Service Life

The worst areas of raveling were in the westbound lane at the beginning of the open graded overlay, where the heaviest application of choker sand was used. Also, raveling was generally greater in the westbound than in the eastbound lane. Observations of truck traffic indicate that the majority of trucks traveling westbound were loaded and those traveling eastbound were not. This may be a result of the pattern of local commerce and a reason for increased raveling in the westbound lane. The open graded mix was in good condition adjacent to the cold mix dense graded areas. Tracking of the fog seal from the dense graded surface to the open graded surface is a possible explanation for this better performance.

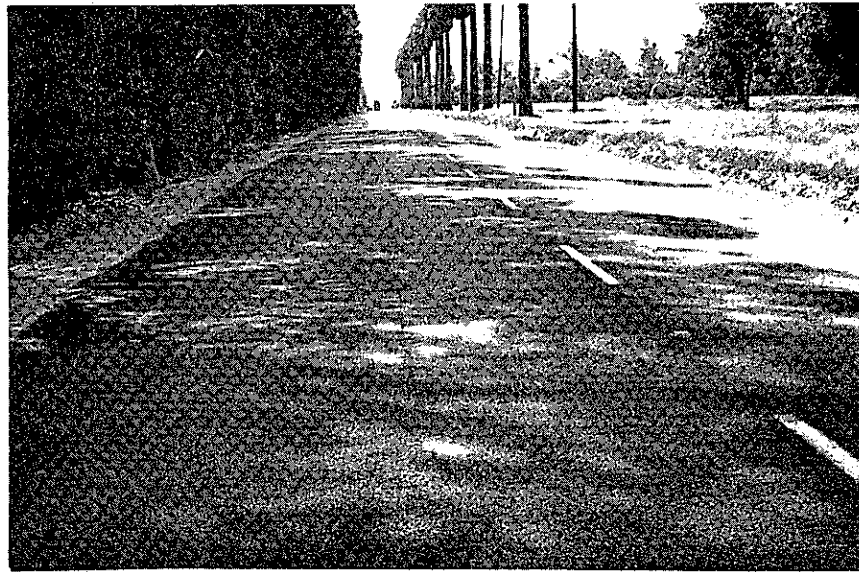
There are areas of raveling extending through the experimental surface but the overall condition was not too bad. However, longitudinal construction joints were visible in certain locations (Figure 16).

Figure 16 - Overall Appearance of Open Graded Mix in a Not Too Raveled Area. Note Longitudinal Construction Joint.

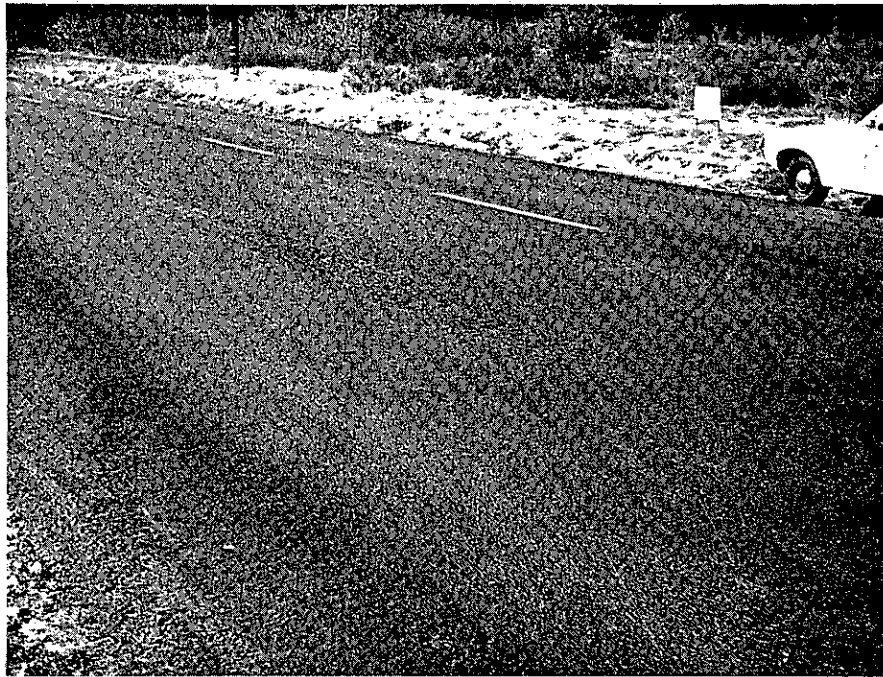
The 90-day pavement survey indicated that dense graded mix in the area where fog seal was not applied had substantial surface raveling (Figure 17). The dense graded mix with fog seal also had surface raveling (Figure 18); however, it was difficult to determine whether it had increased in severity. District personnel feel there has been some progression since the first occurrence. A small amount of hairline cracking was also noted.

Figure 18 - Raveling in Dense Graded Surface
(Fog Seal - 90 Days)

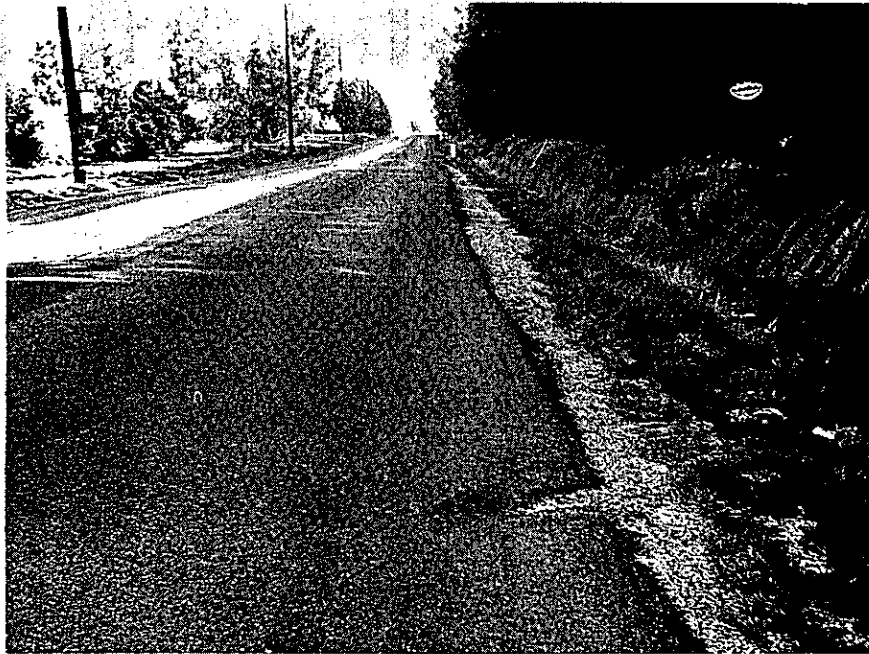
Edges of the mix were friable and easily displaced with foot pressure as in the case of the open graded mix. Also, some loss of material from the edge at the lanes was noted (Figure 19).

Figure 19 - Friable Shoulders Due to
Lack of Compaction

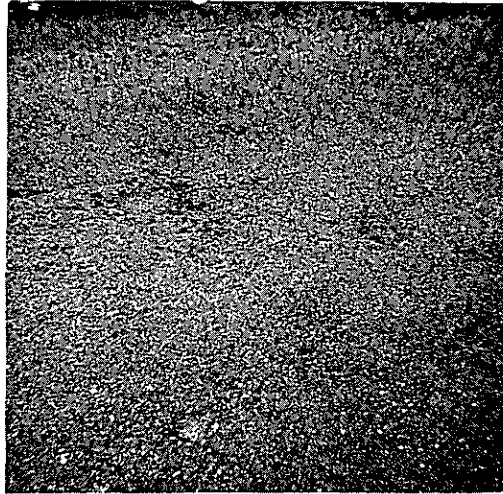
Figure 20 - Isolated Aggregate Pop-outs in Dense Surface (No Fog Seal - Six Months)

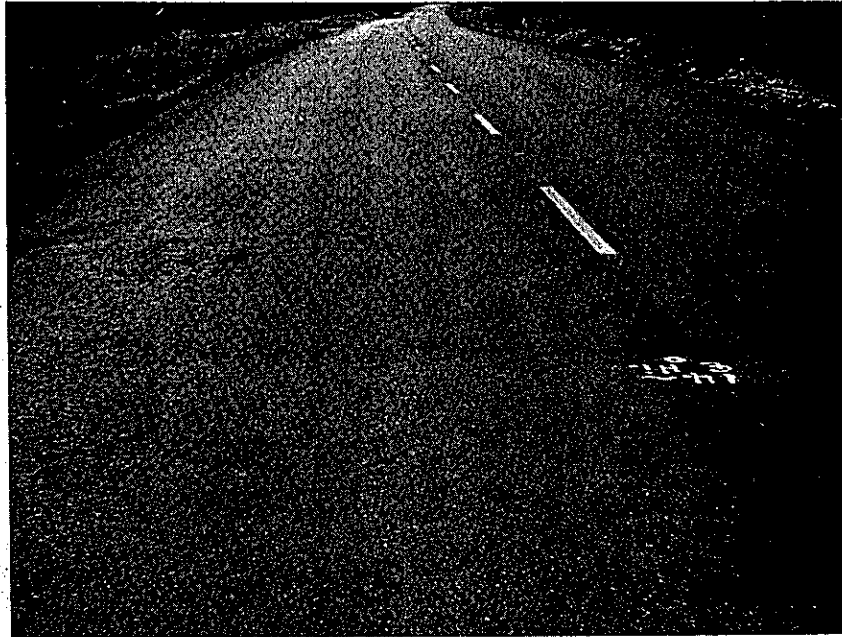
the effects of raveling caused by the original fog seal though some signs still appear and in some areas there is evidence of the longitudinal construction joint (Figure 22). The unsealed area had continued to deteriorate and was definitely in

Figure 22 - Evidence of Raveling and Construction Joint in Dense Graded Surface After One Years Service Life

need of a maintenance seal. Crescent shaped slippage cracks, caused by the heavy truck traffic shortly after paving, were still present and in one case the material had raveled through to the overlayed pavement in an area approximately 6-inches in diameter.

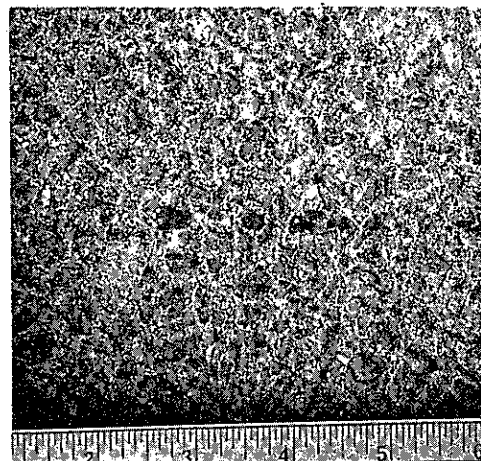
The first section of open graded mix had noticeable surface raveling (Exhibit 3) and two or three areas were raveled through to the overlayed surface. Subsequent sections of this mixture showed less severe raveling. It was felt that raveling in the first section was due, at least in part, to placing the sand choker too early, which retarded curing and resulted in a lack of surface cohesion. Raveling was generally confined to the wheel track areas.

24 Hrs. of Traffic
(5)

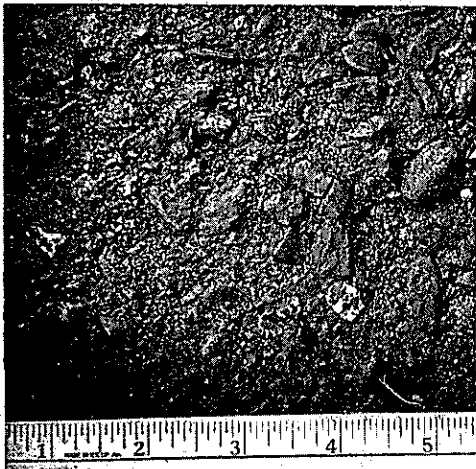
After 24 Hrs. Traffic
(Before Fog Seal)
(3)

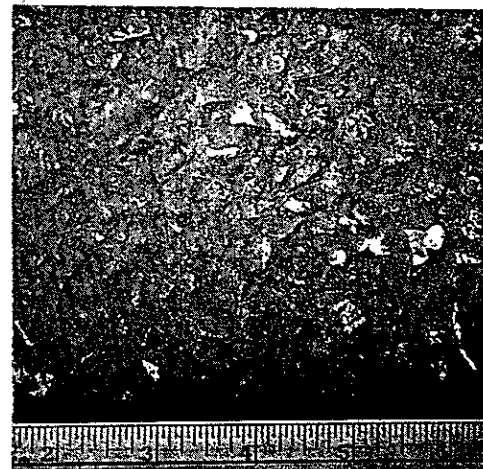
After 90 Days
(4)
